B/1965 B/1995

PROCESSOR 9-9S

CLOCK ALIGNMENT A 2233 3686 D

MAINTENANCE GUIDE

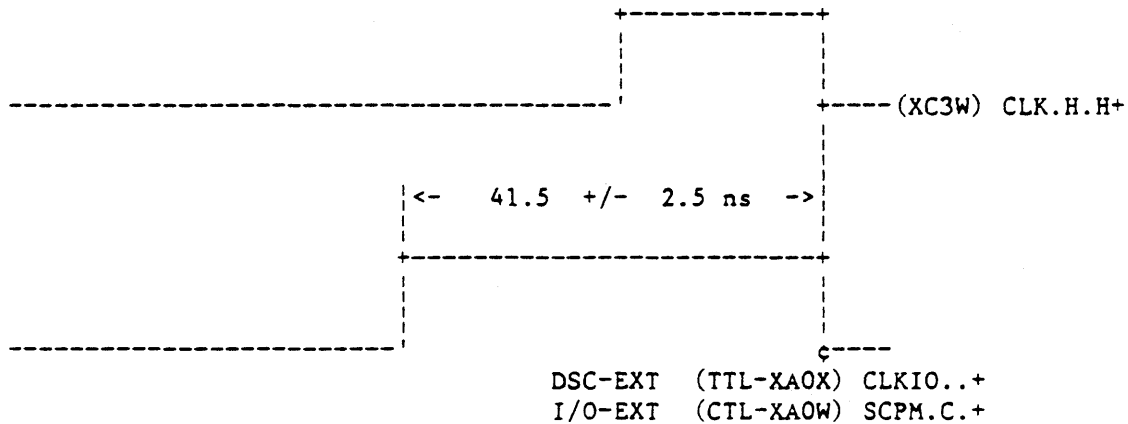
With the card inserted, place channel 1 probe on the processor clock CLK.H.H+ on XC3W of the H9 card. Place channel 2 probe on the backplane of the I/O sub-distribution card at clock CLKIO..+ on pin XAOX for DSC EXT or at clock SCPM.C.+ on pin XAOW for CTL controls. Control the pulse width of the clock to be 41.5 +/- 2.5 ns.
