HP 3000 Computer Systems

**SERIES 64A/B and
68A/B/C to SERIES 70**

Hardware Upgrade Installation Manual

Part No. 30163-90001
E0486

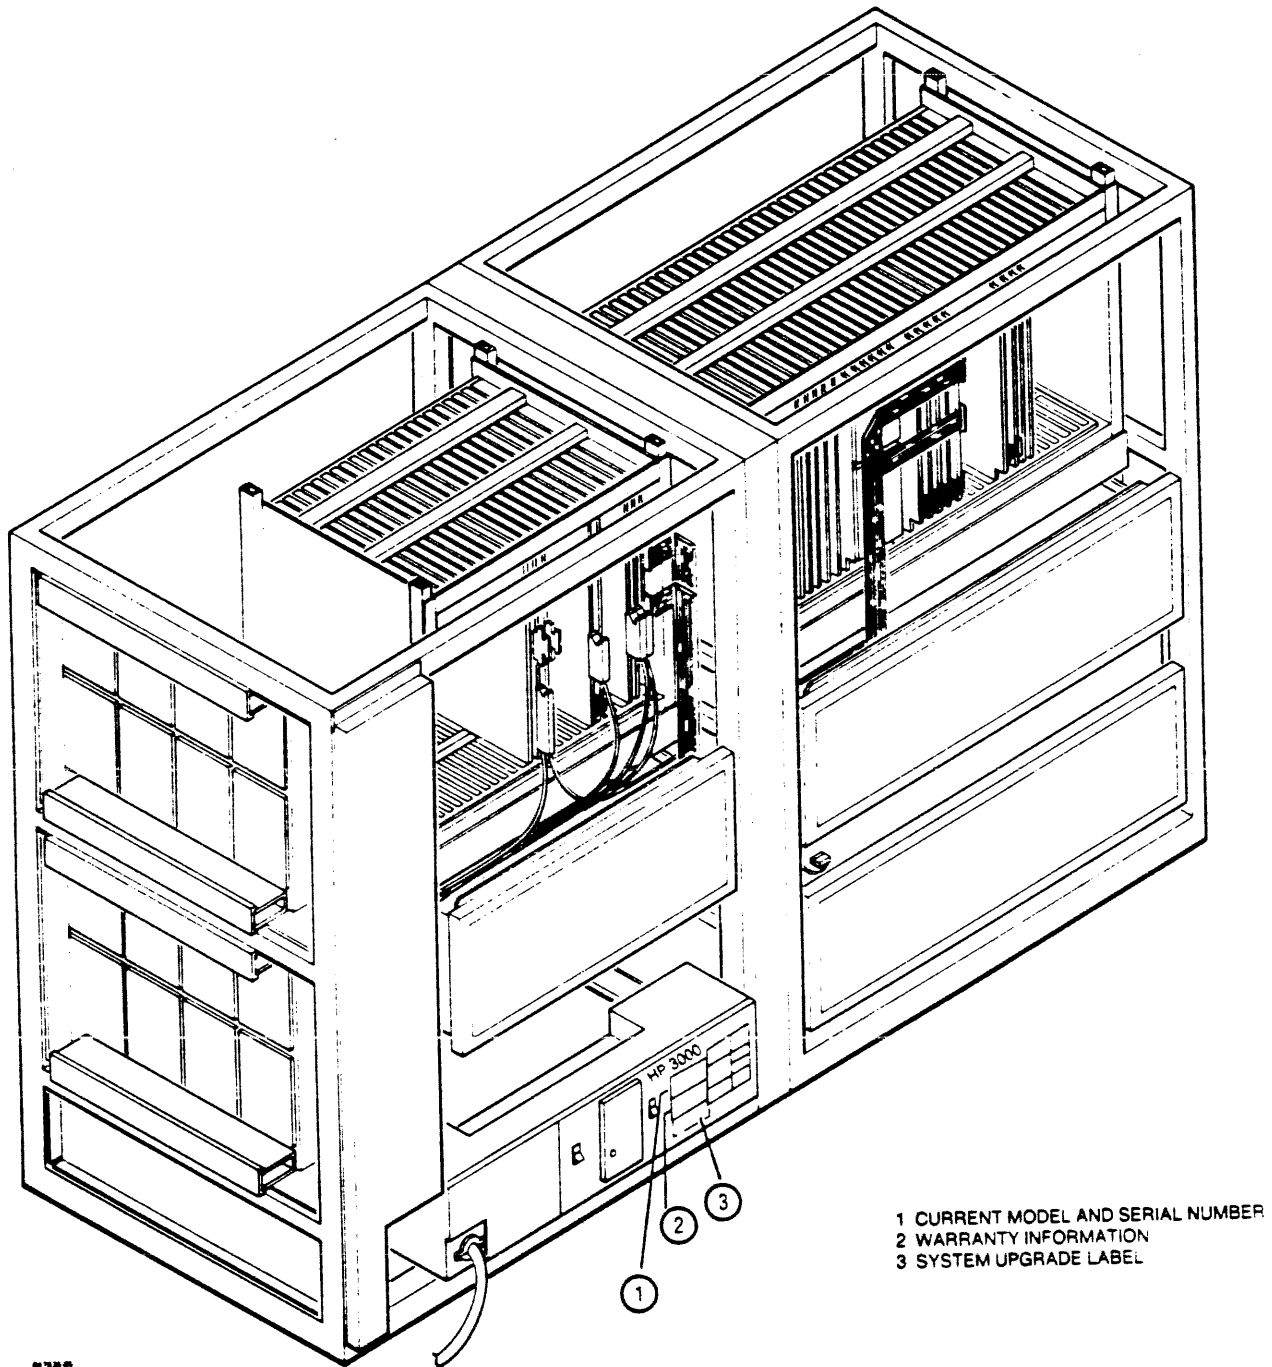
Figure 1-1. SPU Rear View (HP 32460A/68A), Panels Removed.

1. Set Main POWER Switch to OFF. (For the 64A/68A, it is located on the Power Control Module as shown in Figure 1-1, and for the 64B/68B/68C it is located on the AC Unit as shown in Figure 1-2, both in lower rear of I/O Bay.)
2. Remove rear panels of CPU Bay.

1. Locate the existing printed label for your upgraded Series 64 or Series 68 Computer System marked "HP 3000 Series 64" or "HP 3000 Series 68", on the rear of the first I/O Bay. (For Series 64A/68A it is located to the right of circuit breaker CB2 on the Power Control Module as shown in Figure 1-1, and for Series 64B/68B/68C it is located to the right of the AC input power cord and ON/OFF Switch, as shown in Figure 1-2.)
2. Attach the appropriate system upgrade label that identifies which Series 70 product number the system is upgraded to (marked as Product Number 30443A, 30443B, 30444A, or 30444B). This label must be attached directly underneath the existing two labels that reference (1) the current model and serial number, and (2) the warranty information. (See Figure 1-1 or Figure 1-2, as applicable.)

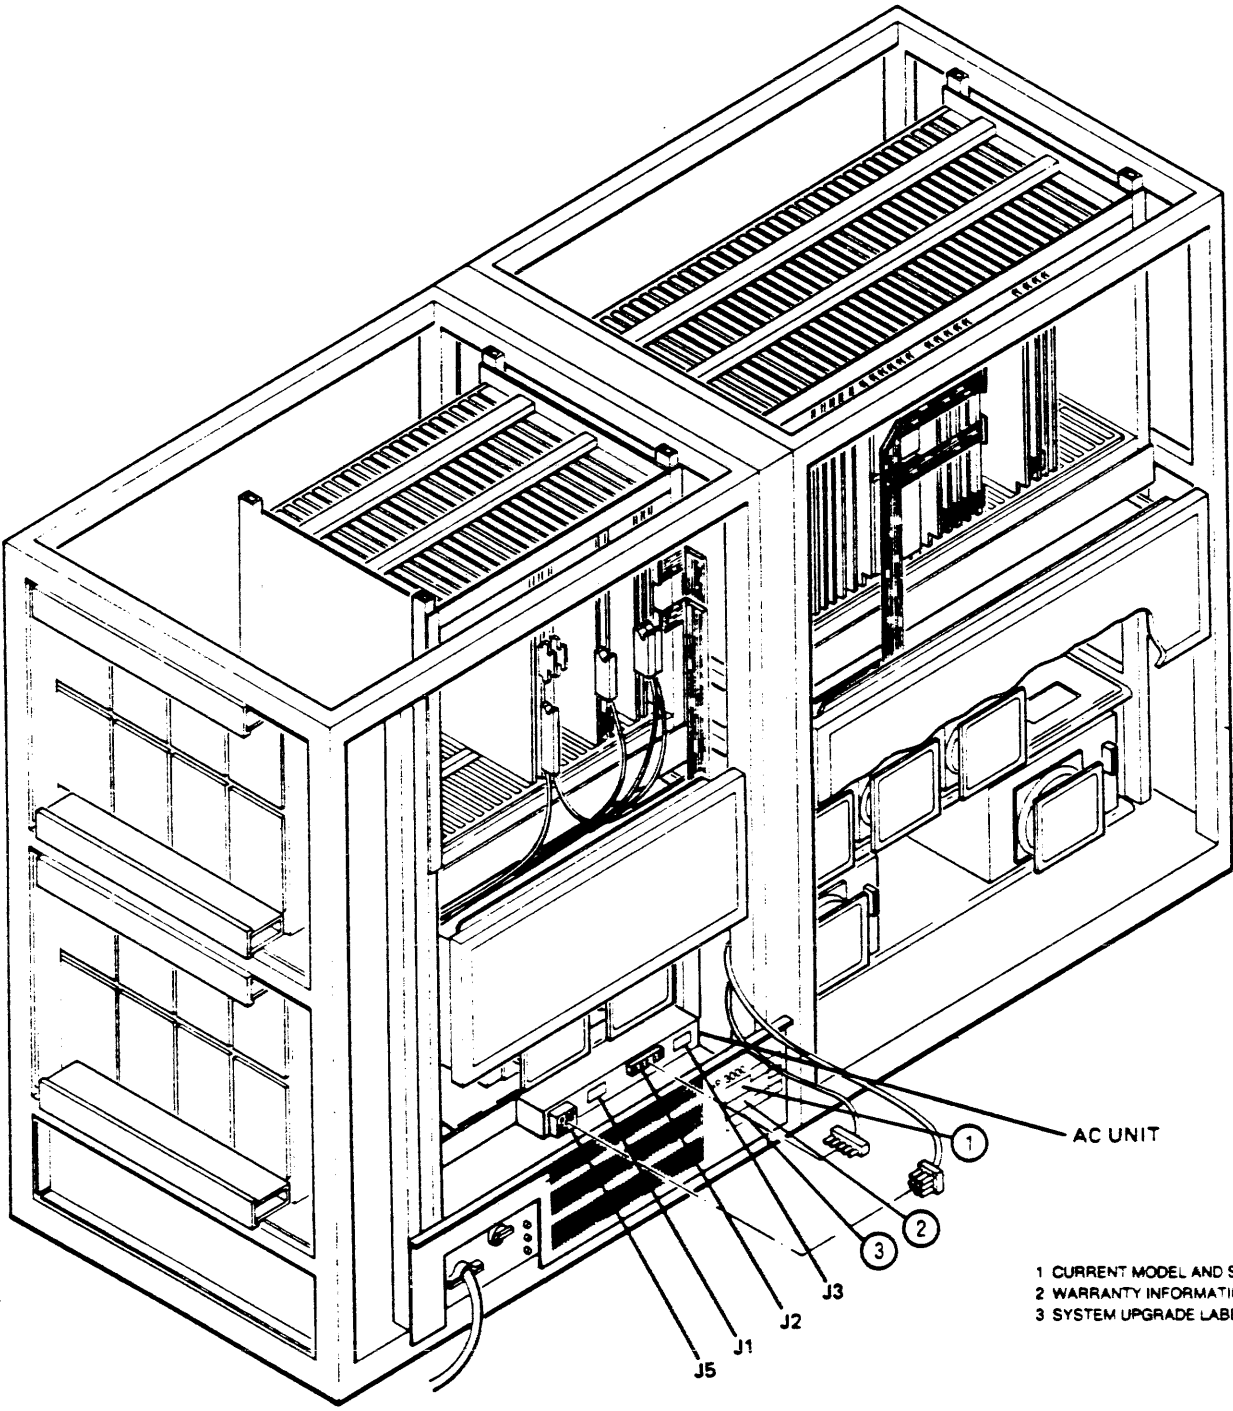
Figure 1-2. SPU Rear View (HP 32460B/32468B/32468C), Panels Removed.

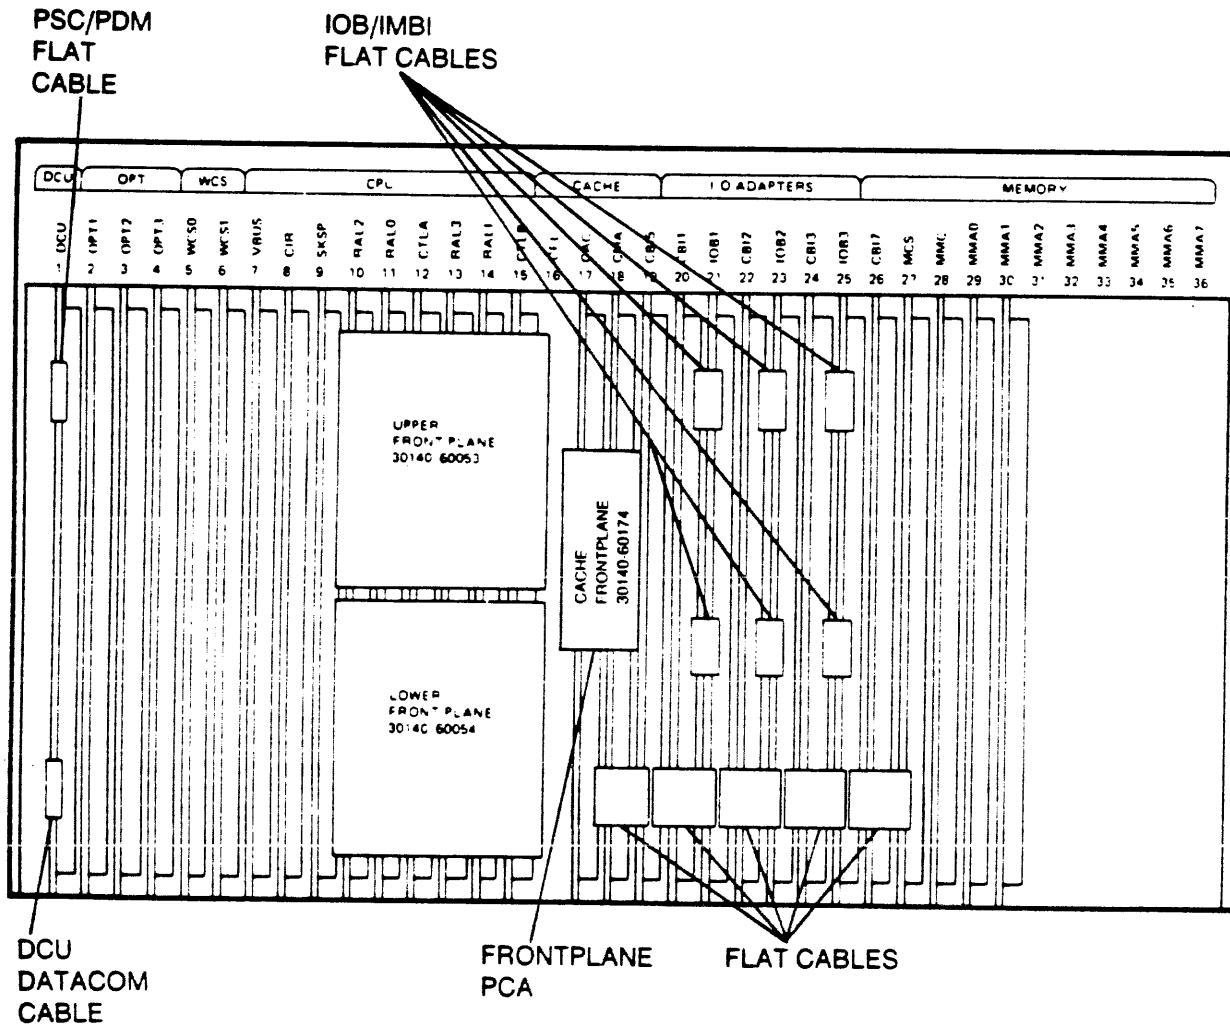
Figure 1-3. CPU Card Cage Assignment, Rear View.

3. Disconnect the three-connector flat ribbon cable (P/N 30140-60029) that connects the J5 edge connectors of CAC, CMA, and CBI5 PCAs. (See Figure 1-3 for illustration of CAC, CMA, and CBI5 PCA location.) Discard this three-connector flat ribbon cable.

4. Remove the CAC PCA (P/N 30140-60009 or P/N 30140-69009) from slot 17 and the CMA PCA (P/N 30140-60010 or P/N 30140-69010) from slot 18 of CPU card cage. (See Figure 1-3.)

5. Insert the new CACX PCA (P/N 30140-60172) into slot 17 and the new CMAX PCA (P/N 30140-60173) into slot 18 of CPU card cage. (See Figure 1-3.)
6. Connect the two-connector flat ribbon cable (P/N 30140-60028) to the J5 edge connectors of CMAX and CBI5 PCAs. (See Figure 1-3.)

7. Connect Cache Frontplane PCA (P/N 30140-60174) to the J4 edge connectors of CACX and CMAX PCAs. (See Figure 1-3.)
8. Ensure all card cage fans and filters are dust-free and in normal operating condition. Replace as necessary.
